STRUCTURAL ELEMENT TESTING AND REAL BLADE IMPACT  
TESTING VOLUME I(CU) DAYTON UNIV OH RESEARCH INST  
R S BERTKE JAN 83 UDR-TR-82-83-VOL-2

STRUCTURAL ELEMENT TESTING AND REAL BLADE IMPACT TESTING

UNIVERSITY OF DAYTON RESEARCH INSTITUTE  
300 COLLEGE PARK AVENUE  
DAYTON, OHIO 45469

FINAL REPORT FOR PERIOD OCTOBER 1977 - JUNE 1980

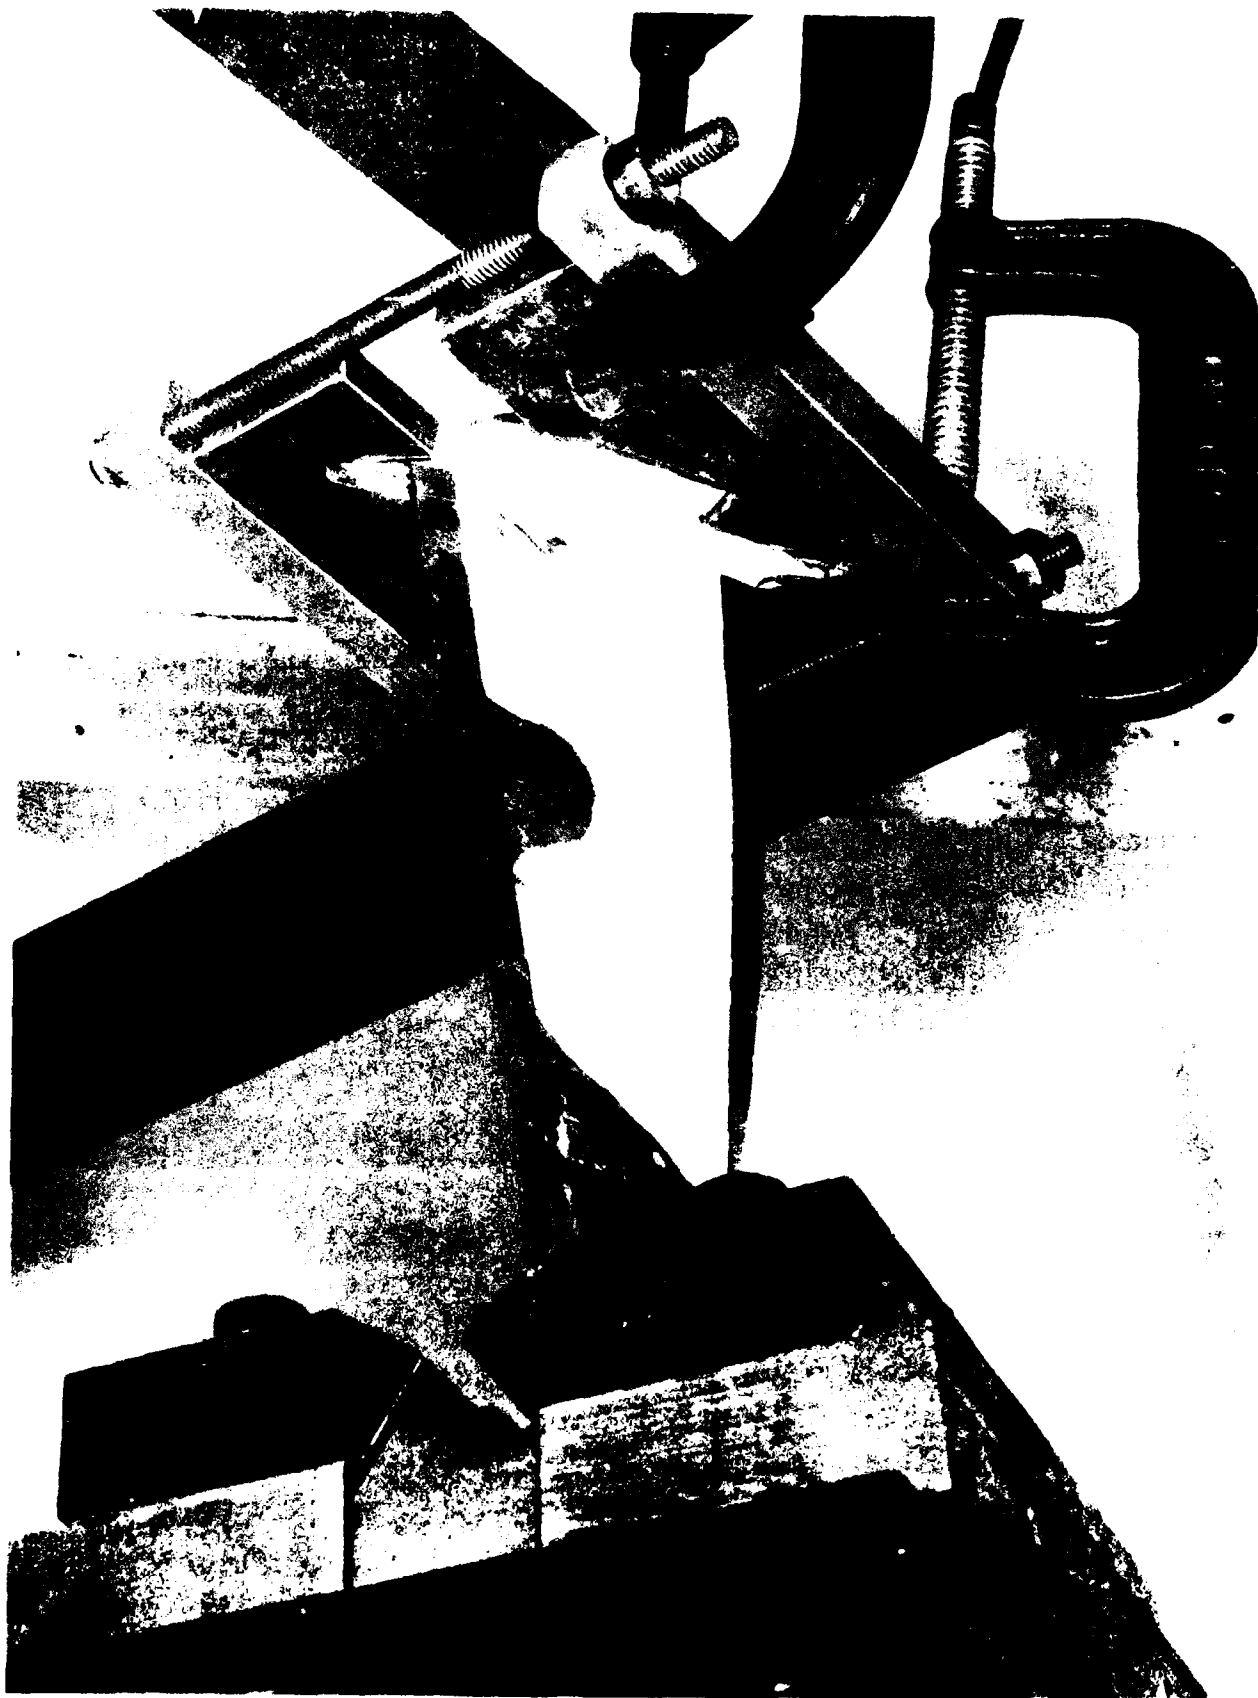
Figure 4. Photograph of Technique Utilized to Restrain F101 Blade Tips.

In the case of the F101 blades, the tips were also restrained to simulate the tip shrouds in the actual engine. Figure 4 shows the system utilized to restrain the tip of the F101 blades.
